Hydrosight Stainless steel mullion with tile finish

Project:13606  
 Author: J.Meyer  
 All dimensions in mm  
 Wednesday, May 07, 2025

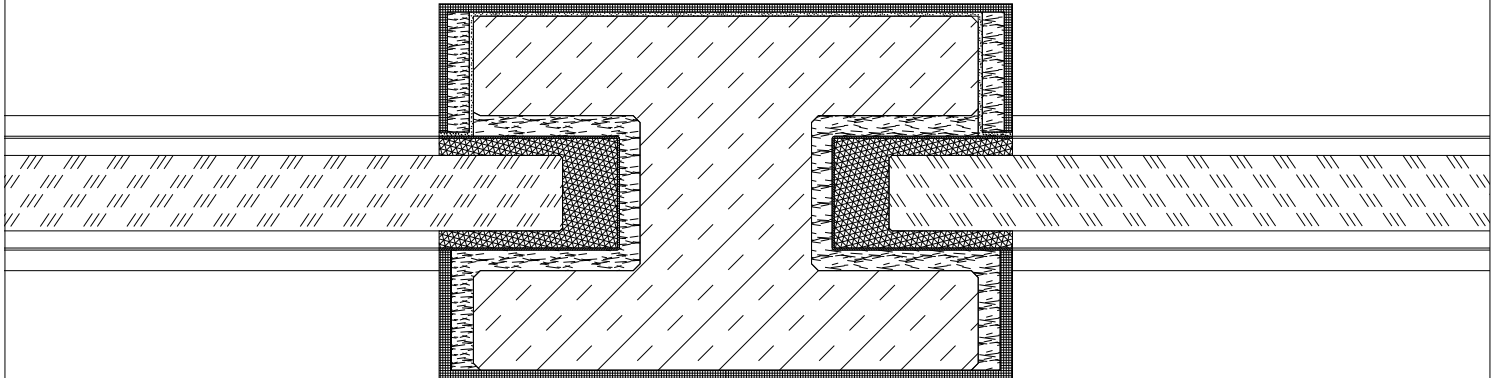
Mullion in between the two 9m glazings, made of steel reinforced concrete.

Reinforced Concrete / Stahlbeton
	Mortar / Stopfmörtel oder Versetzmörtel
	Stainless Steel Frame(1.4571/ 316Ti) / Edelstahlrahmen(1.4571)
	Ceramic Tiles, Tile Adhesive / Fliesen, Fliesenkleber
	Water proofing, waterproofing tape / Wasserabdichtung, Dichtband
	Waterproofing Material / Dichtstoff
	Sealant (cosmetic, installed by others) - e.g. Dow Corning 791 / Silikon (nicht dichtend, bauseits) - z.B. Dow Corning 791
	Acrylic Window Block / Acrylglas-Fenster
